## Laboratory and Equipment

## Tested Light Source

| Manufacturer | Moon On Noon |

## Main Light Measurement Results

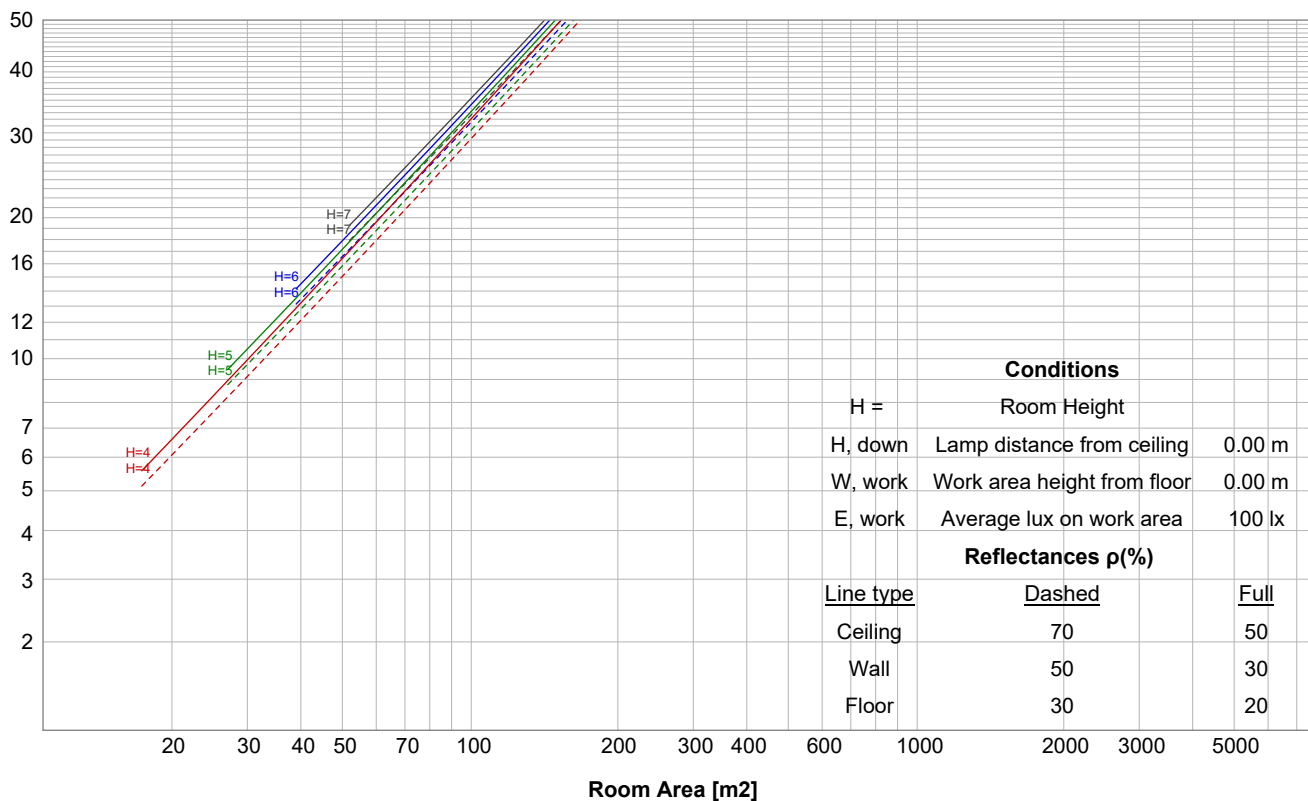
## Luminaire budgetary diagram

LAMPS (number of lamps)

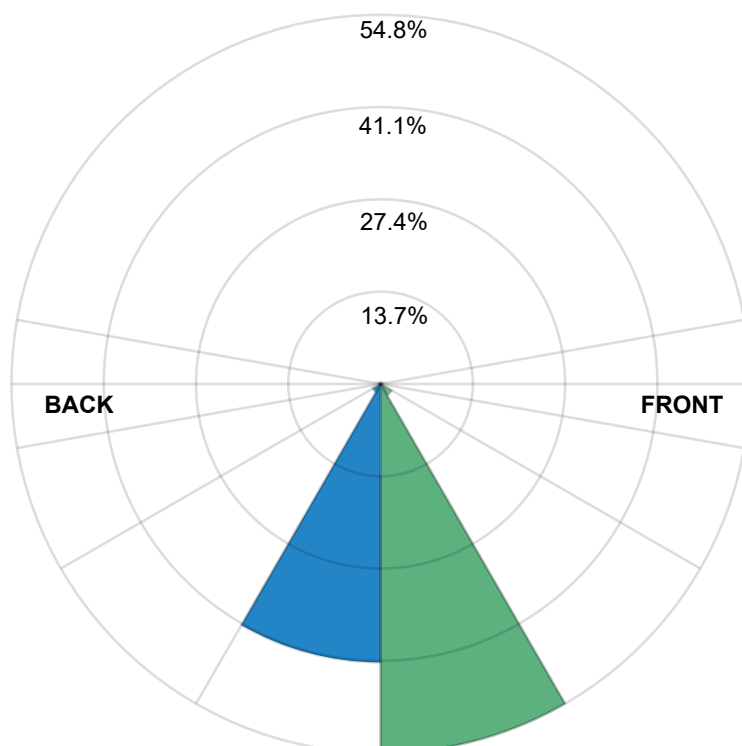
## IESNA TM-15-07 Luminaire Classification System For Outdoor Luminaires

BUG rating B1 U0 G0
